**Milton Regis Conservation Area
Character Appraisal and Management Strategy**

PUBLIC CONSULTATION DRAFT September 2023

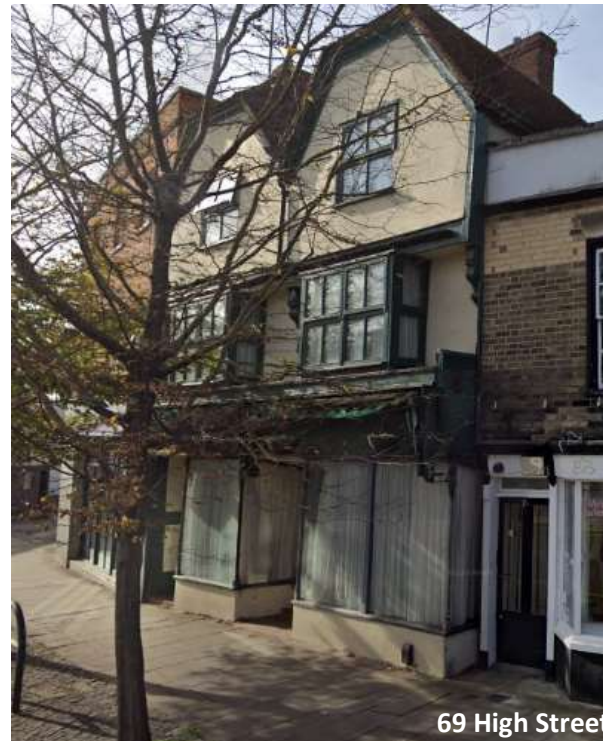
69 High Street is a late 17th century 3-storey timber-framed house. In this instance, the timber frame was never designed to be seen as it was concealed behind plaster from day one. The jettied top floor and twin half-hipped roofs are characteristic of the date.

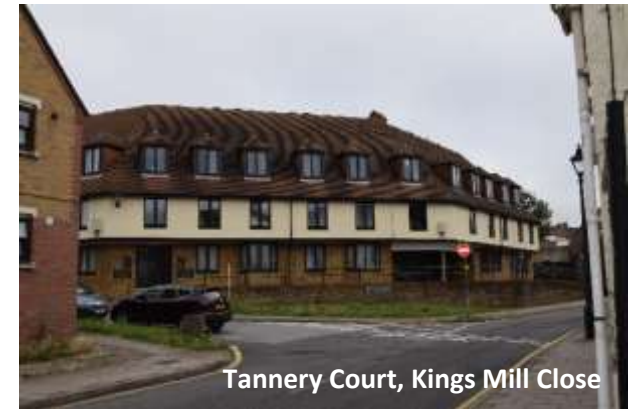
More recent buildings include Tannery Court, Kings Mill Close and 9 to 19 (odd) Crown Road which replaced a petrol filling station. All are successful developments because of the way in which they positively respond to the local vernacular in their form, materials and design.

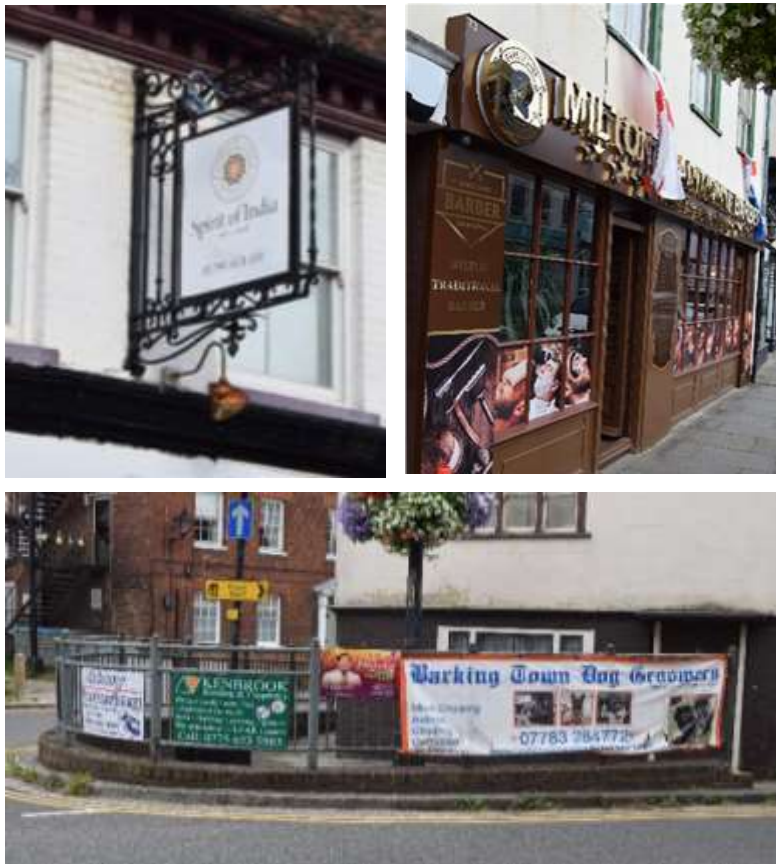
There are some good examples of traditional signage in the conservation area such as the wrought iron pub sign at 91 High Street. However, there are also many poorly designed or executed signs using inappropriate materials or oversized fascia boards which detract from the buildings and the conservation area. Advertising boards placed on the footway and banner signs attached to pedestrian railings do not do the area justice.

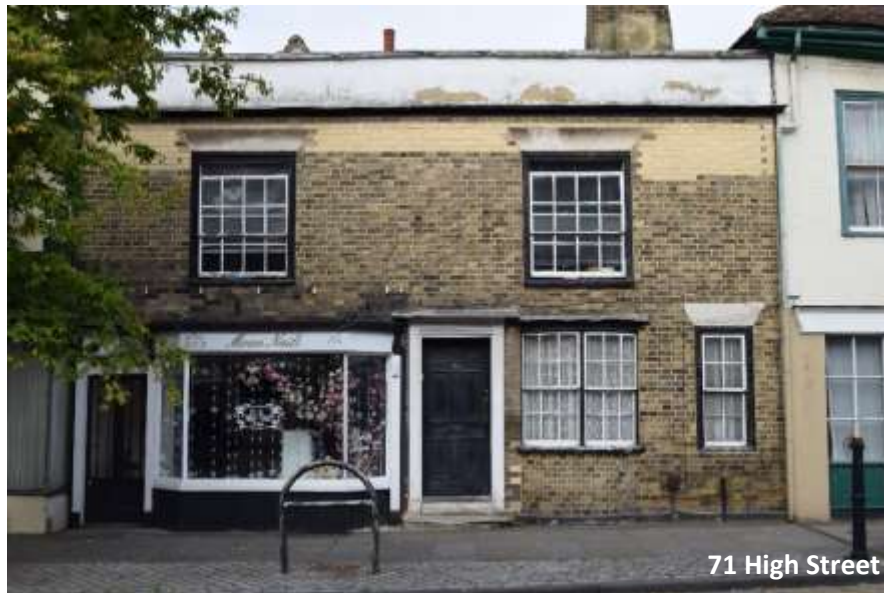
Mathematical tile: Mathematical tiles are flanged tiles made from fired clay. They are made so that when hung on a wall, their vertical face is almost indistinguishable from brickwork. They were used in parts of the south-east to provide fashionable elevations to timber-framed buildings during the 18th and 19th centuries. The front elevation of 71 High Street is a good example.

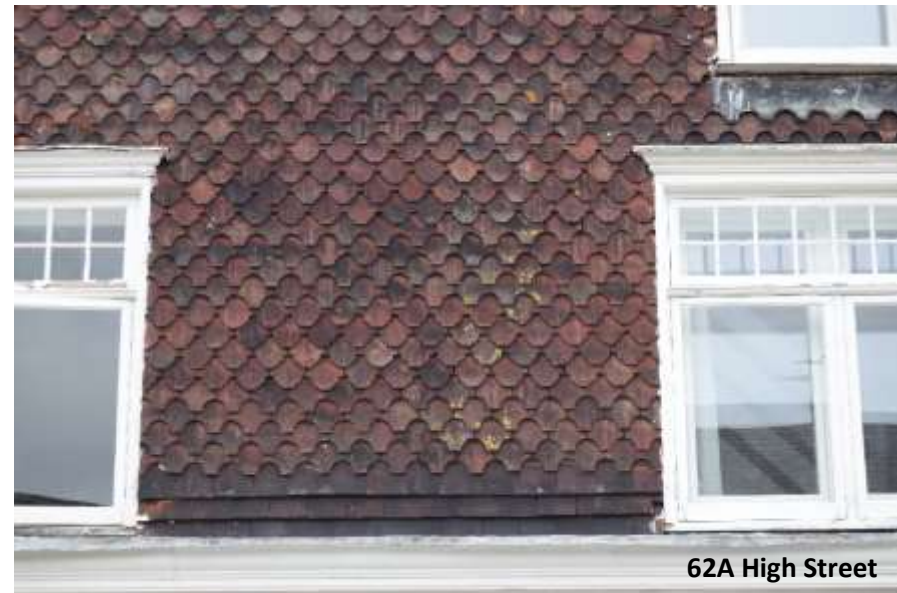
Kent peg tiles: The name 'peg tile' refers to a plain clay tile that is suspended from the top edge of a tiling lath by a peg. Traditionally peg tiles were held in place by a small wooden peg or latterly an aluminium 'drop', wedged into, or passed through one of two holes in the head of the tile. Simple firing methods and local clays produced strong, durable and light peg tiles in warm orange/red terracotta colours. Imperfections in the raw clay, combined with the hand manufacturing process, resulted in a richness and variety in colour and shape. They are renowned for their warm, varied colours and rich texture which cannot be replicated in modern machine-made tiles.

Until the 19th century, locally produced hand-made clay peg tiles were the preferred roof covering for buildings throughout Kent. Tiles continued to be handmade from local clays well into the 20th century and there are still a handful of manufacturers today. They are a characteristic roofing material in the south-east of England and prominent in the roofs of Milton Regis. Kent peg tile roofs are visually prominent because of their steep pitch (typically steeper than 35 degrees). Tiles are also used as 'tile hanging' on external walls, sometimes with decorative shapes, as seen on the front elevation of 62A High Street.

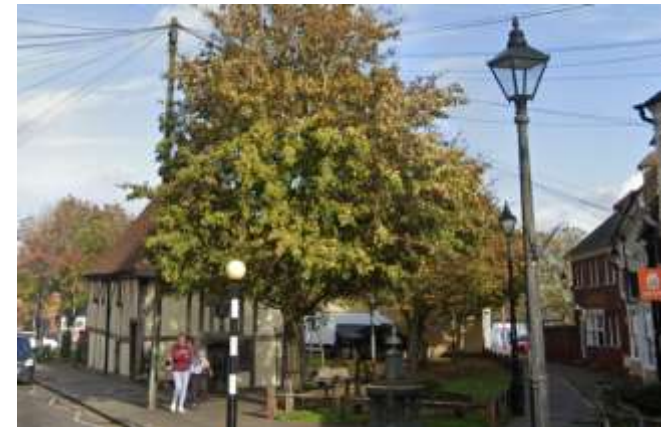
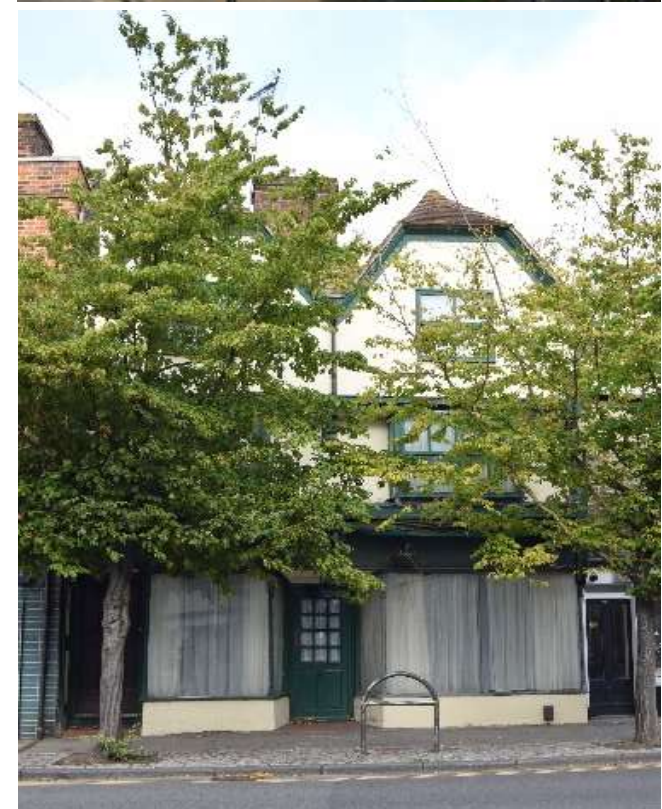
There are a number of public trees within the conservation area which are in need management and maintenance. Those outside 69 High Street, currently obscure the building and could damage it if not cut back. There are also empty tree pits and a dead tree stump in the vicinity of the Court Hall which give the impression of neglect. Grass landscaped areas around the Court Hall car park are poorly maintained.

- An audit of trees could be undertaken to establish a proper management regime and identify opportunities for planting new or replacement trees.
- Consideration could be given to the replacement of concrete highway kerbs with more traditional kerbs.

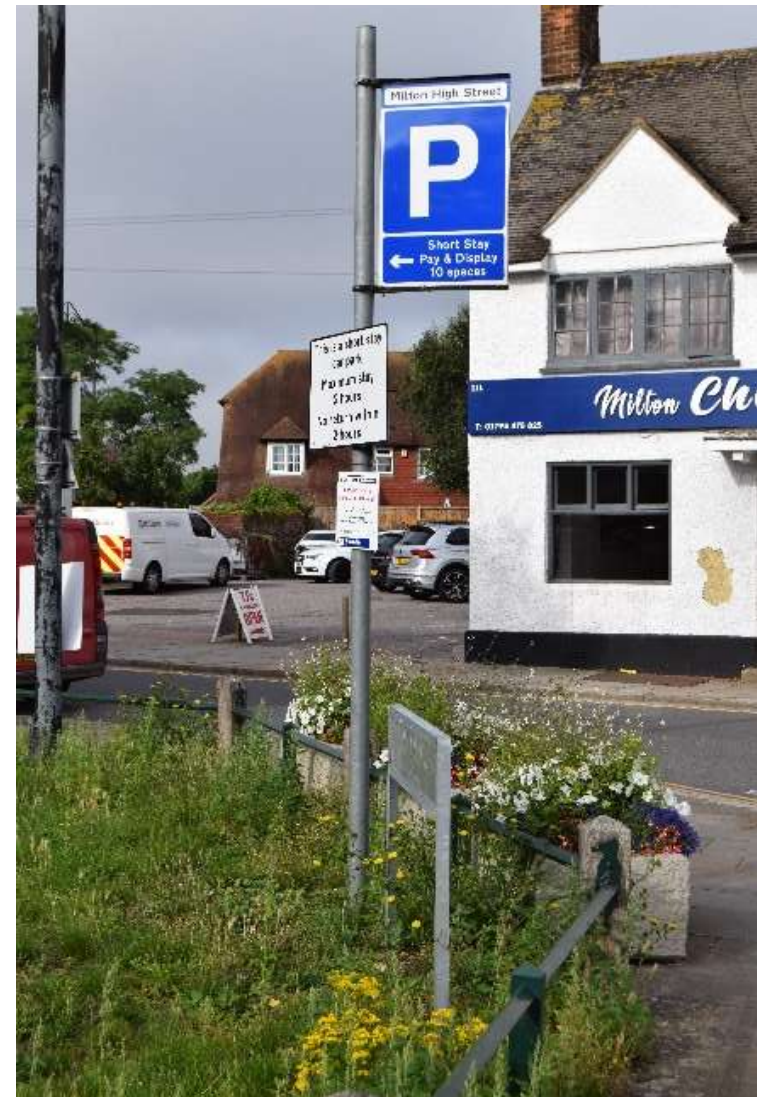
Highway signs and street furniture. Restrained use of highway signing and road markings is also critically important to the character of the conservation area. Where signs, road markings, street furniture, salt bins, rubbish bins or utility boxes are deemed necessary, they should be located and designed sensitively and in consultation with the local community.

The blue and white enameled street name sign 'The Cross' mounted on 104 High Street is an important survival from the late 19th or early 20th century. It could be used as a pattern for the production of other street signs within the conservation area.

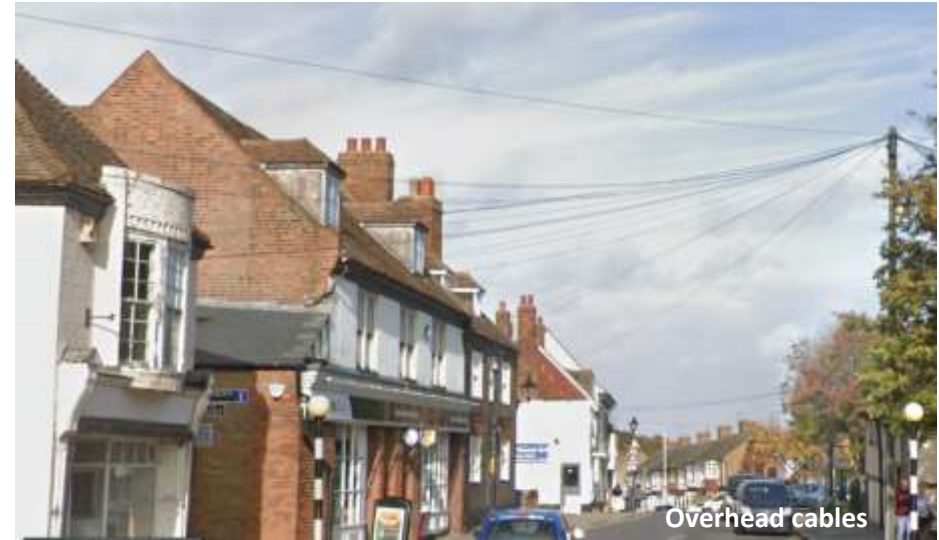
Trees and landscaping. There are several public trees within the conservation area which are in need proper management. There are also empty tree pits and a dead tree stump which give the impression that the area is being neglected. Grass areas around the Court Hall car park were poorly maintained at the time of the appraisal.

- An audit of street furniture (bollards, benches, bins, salt bins, bus stops etc.) could be undertaken to establish whether all street furniture is necessary, well designed and appropriately located. It could also identify maintenance and repairs that are required.

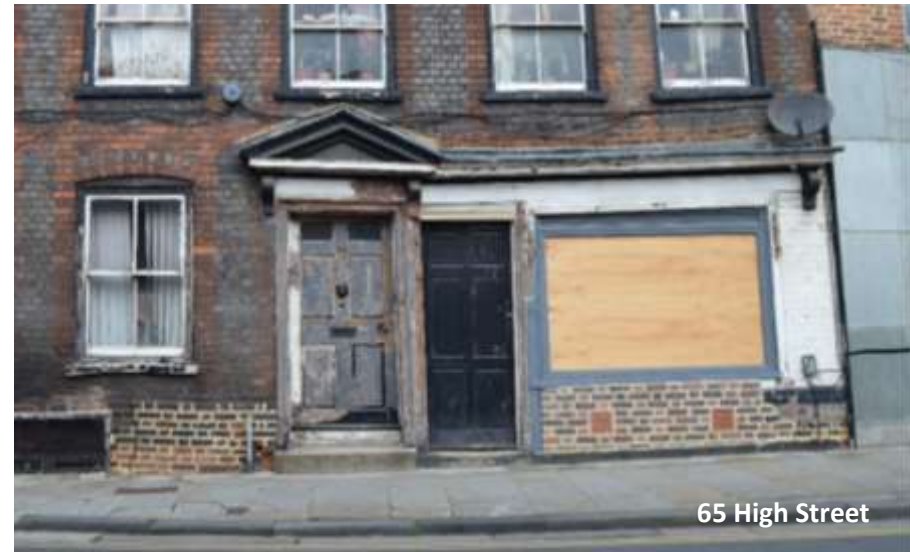
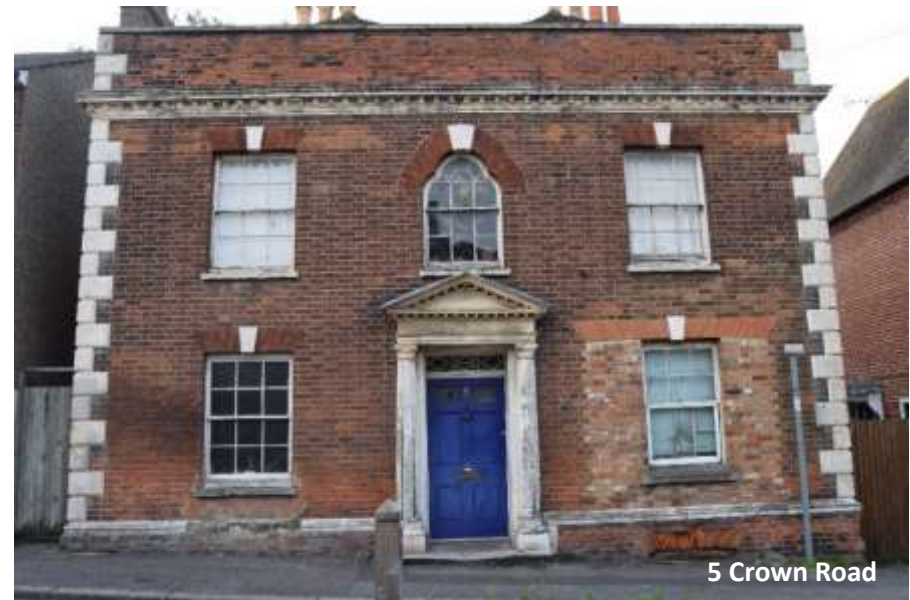
Tree and landscape management are areas for the appropriate authority (SBC or KCC) to address. The bin and commercial signage problem on the footway is an enforcement issue (SBC or KCC).

The 'at risk' buildings are typically in private ownership, requiring repair and investment to remove the real threat posed by under use, decay and deterioration. Swale Borough Council could consider approaching owners to discuss how issues of neglect and deterioration could be addressed. The next step would be to consider using statutory powers to achieve the repair of the buildings in the public interest. The statutory powers available to the Council include Repairs Notices, Urgent Works Notices, Section 215 Notices and ultimately Compulsory Purchase.
