Cabinet Meeting		Agenda Item: 10
Meeting Date	15 March 2017	
Report Title	Sheerness Paddling Pool - Options	
Cabinet Member	Cllr David Simmons, Cabinet Member for Environment and Rural Affairs	
SMT Lead	Dave Thomas, Head of Commissioning and Customer Contact	
Head of Service	Dave Thomas, Head of Commissioning and Customer Contact	
Lead Officer	Martyn Cassell, Leisure and Technical Services Manager	
Key Decision	No	
Classification	Open	
Forward Plan	Reference number:	
Recommendations	<ol style="list-style-type: none"> 1. To approve funding of up to £22,500 for upgrading the plant, water features and surfacing as detailed in section 2.7 (required works) and keep the facility open for residents and visitors.

Appendix I – Photos of current site condition

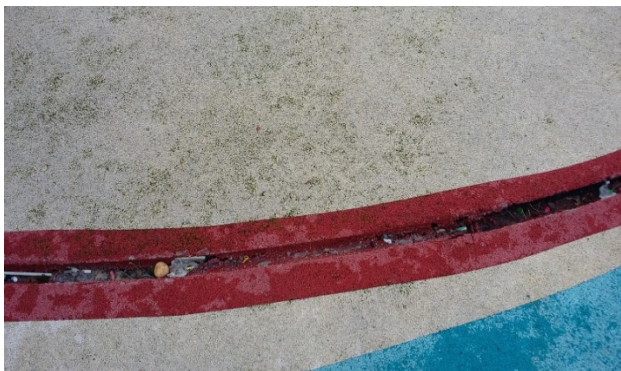
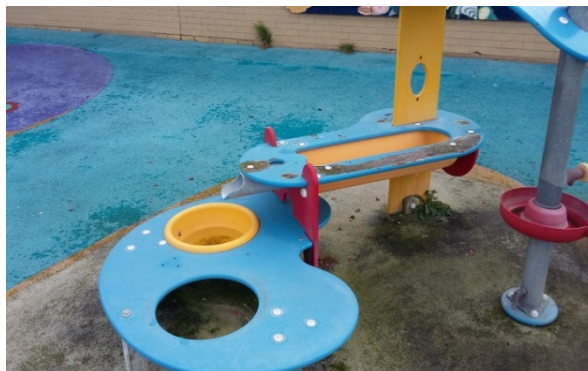
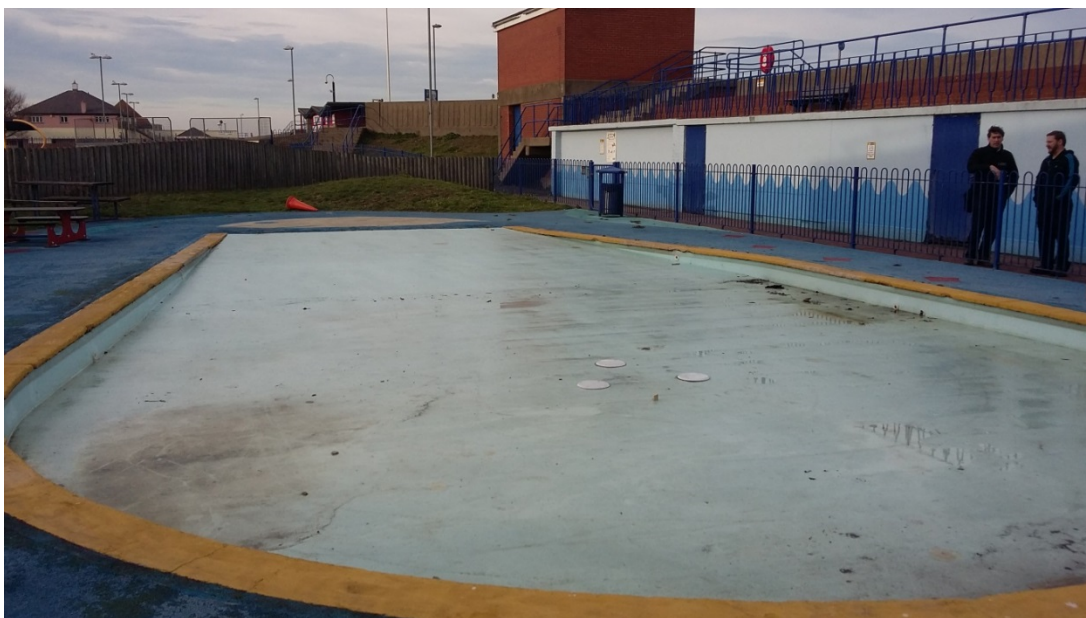
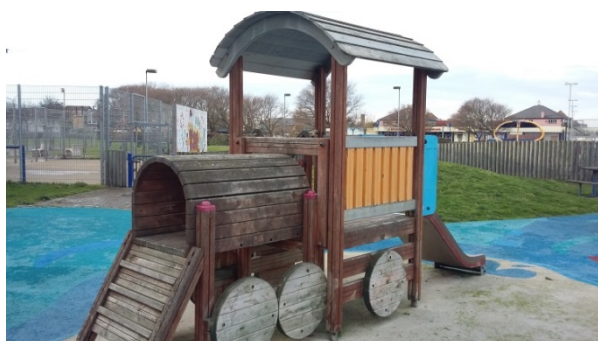
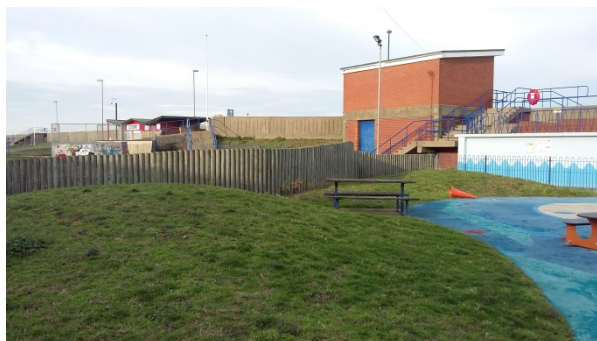
- The heavy usage at peak times puts a strain on the existing equipment. The landscaping of the site, whilst visually appealing, contributes to further issues with the pool filtration system. Grass and mud from the landscaping and the break-up of the flooring all contribute to blocking the chemical filters and putting water quality at risk.

- The play equipment and street furniture (bins/benches) are old and require repair/replacement.
 - The safety surfacing around the pool is tired and some areas need urgent repairs.

- The pool lining and suction grills are damaged and pose a risk to children landing on them.
- 2.7 A discussion with Serco maintenance operatives has prioritised the works that would need to be undertaken as a minimum if they were to continue with the operation of the facility and can be seen in table 1 below;

Rectification	Estimated Cost	Priority
Remove natural grass on mounding and cover with suitable surface	£7000-10,000	Required

Add additional filters to the plant equipment	£2000	Required
Repairs to the damaged/unsafe safety surfacing (EDPM)	£2000	Required
Repair suction gratings	£1000	Required
Pool liner repairs	£4000	Required
Repairs to playground equipment	£2000	Required
Replace two pumps in plant room	£1500	Required
	£22,500	
Review ventilation in plant room	TBC – SCL/Serco to investigate	Optional
Removal of inoperable water features	£5000	Optional
Resurface the worst quarter of safety surfacing (EDPM)	£20,000	Optional
Full replacement of pool plant system	£25,000	Optional
